DEPARTMENT OF TRANSPORTATION

Contract #: 04-0120F4Cty: SF/ALA Rte: 80 PM: 13.2/13.9File #: 69.28**WELDING INSPECTION REPORT****Resident Engineer:**Pursell, Gary**Address:** 333 Burma Road**City:** Oakland, CA 94607**Report No:** WIR-003169**Date Inspected:** 23-Jun-2008**Project Name:** SAS Superstructure**OSM Arrival Time:** 700**Prime Contractor:** American Bridge/Fluor Enterprises, a JV**OSM Departure Time:** 1500**Contractor:** Zhenhua Port Machinery Company, Ltd (ZPMC), Changxing Island **Location:** Shanghai, China**CWI Name:** Sun Wei**CWI Present:** Yes No**Inspected CWI report:** Yes No N/A**Rod Oven in Use:** Yes No N/A**Electrode to specification:** Yes No N/A**Weld Procedures Followed:** Yes No N/A**Qualified Welders:** Yes No N/A**Verified Joint Fit-up:** Yes No N/A**Approved Drawings:** Yes No N/A**Approved WPS:** Yes No N/A**Delayed / Cancelled:** Yes No N/A**Bridge No:** 34-0006**Component:** OBG and Tower**Summary of Items Observed:**

OBG Sub-Assembly Bay 1**Deck Panel Production Welding**

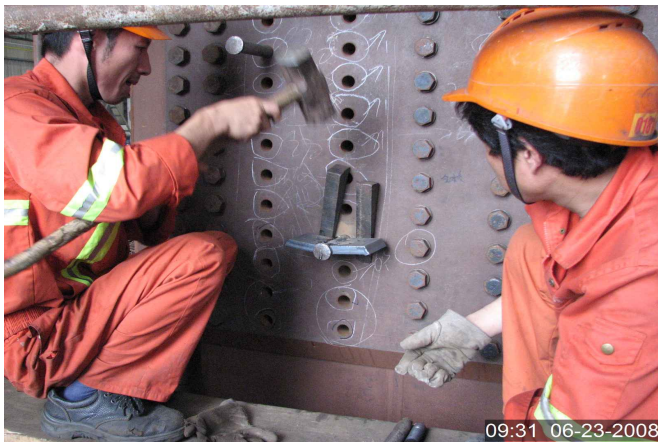
The Quality Assurance Inspector observed 2 ZPMC employees working on the 114M Mock-up Assembly. The workings managed to get a shear stud they were using as a spud stuck in the external bolted connection plate at skin C. ZPMC then welded two plates to the shear stud and pounded wedges in between the plates and the external bolted connection plate. Below is digital photograph illustrating the process.

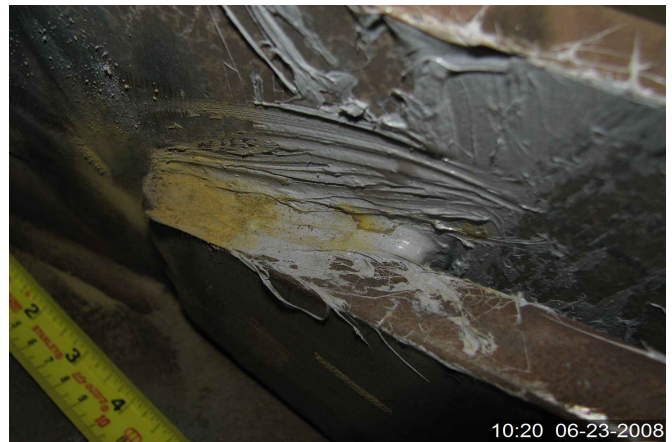
The Quality Assurance inspector observed where ZPMC applied a caulking material to several edge plate skewed T connections. Below is a digital photograph illustrating the issue.
